REPORT

on the survey of selected ecosystems in the territory of the Republic of Uzbekistan (Republic of Uzbekistan, Bukhara province, Republic of Karakalpakstan 27-29 July 2025)

REPORT
on the field assessment mission of ecosystems and protected areas in the
Republic of Tajikistan

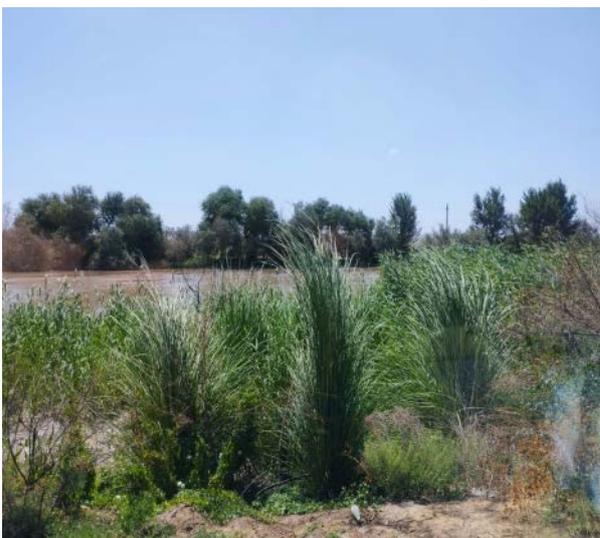
View of ABMC

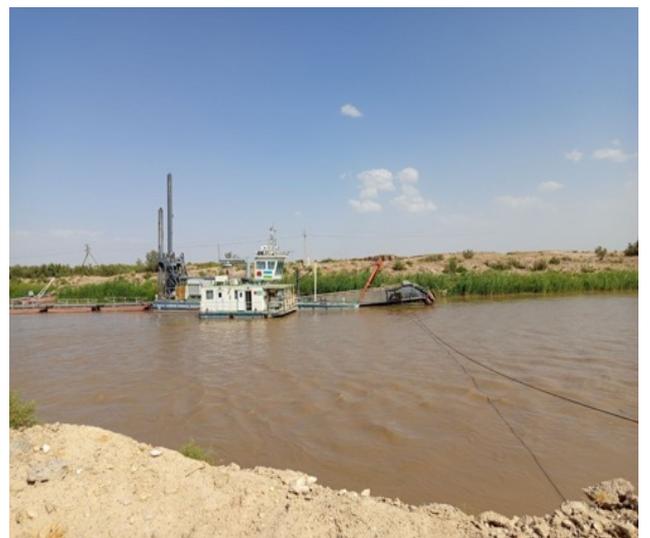
Along the expedition route, efforts on dredging silted sections of the canal were recorded. The team also visited one of the key pumping stations — “Kuyimazar,” which supplies water to the reservoir of the same name. The station was commissioned in 1965 and fully modernized in 2017, including replacement of pumping equipment. As a result of the reconstruction, energy efficiency was improved and energy consumption reduced by 15–20%.

Dredging machine cleaning ABMC's bed

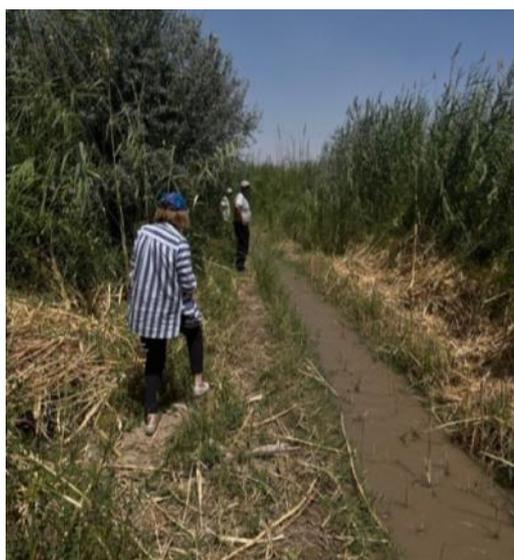
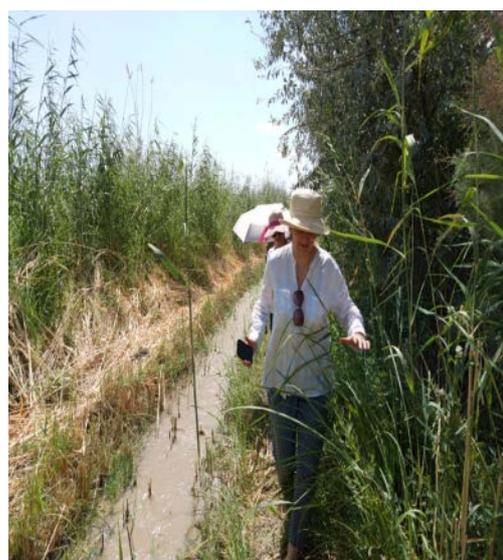
Shokhrukh Canal in the area of nursery

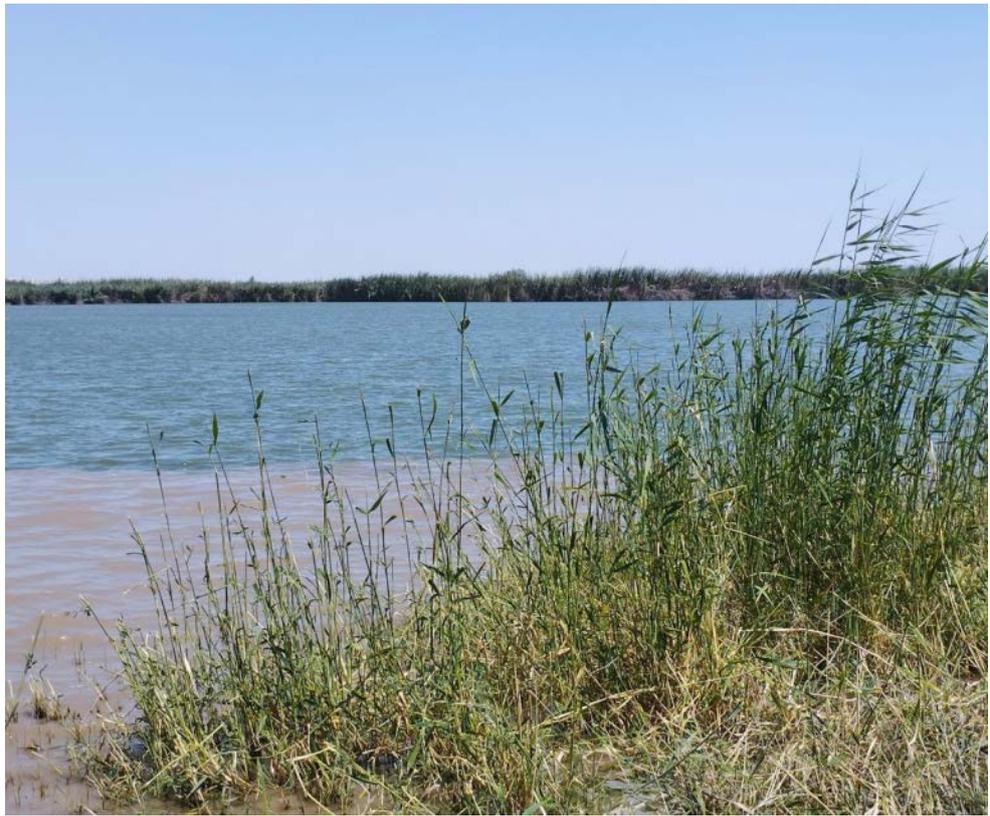
Inflow from the Shokhrukh Canal into lake systems

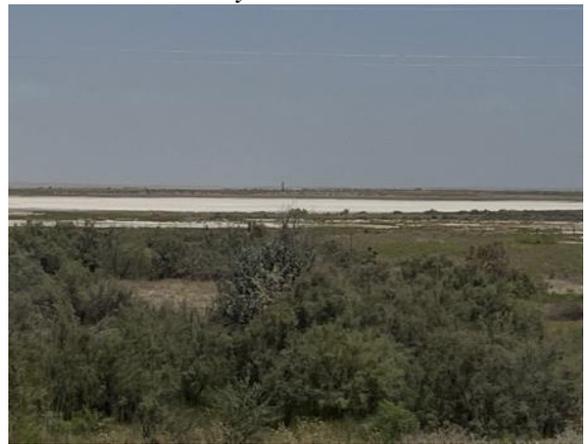
A lake system is located in the south of this territory. It consists of four water bodies with varying degrees of water salinity. They are recharged by water from ABMC via the Shokhrukh Canal. Due to insufficient water supply, one of the water bodies has completely dried up, turning into solonchak. Water is diverted into Shokhrukh Canal without approved water diversion quotas. To preserve the lake system and ensure sustainable functioning of the nursery's ecosystem, it is necessary to calculate the water demand and formally include the corresponding water quantities in the pre-set water quotas.

Water does not reach the fourth lake in low-water years

Jayran Nursery is a unique ecocenter directly relying on water from ABMC. One of the four lakes in its territory has almost completely dried up. The team found that no formal water quota exist for the nursery. This makes the ecosystem quite vulnerable. It is recommended to include the nursery's demand in annual water allocation quotas.

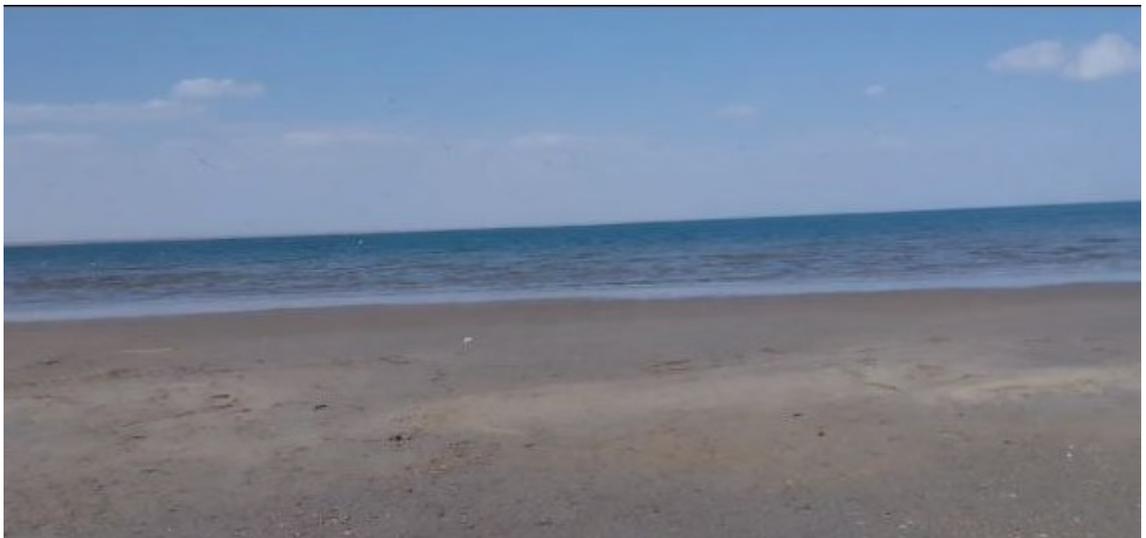
The Tudakul reservoir is located in a natural desert depression (with the water surface elevation of 223.5 m) in Kyzyltepa District of Navoi province, 26 km east of the city of Bukhara. The water body was formed naturally in 1952 as a result of floodwaters from the Zeravshan River breaching into the Tudakul Depression. The reservoir was commissioned in 1968 and reconstructed in 1977. In 2020, the “Silk Road Family Resort” recreation area was opened on its shore, increasing the recreational pressure on the ecosystem.

View of the Tudakul reservoir

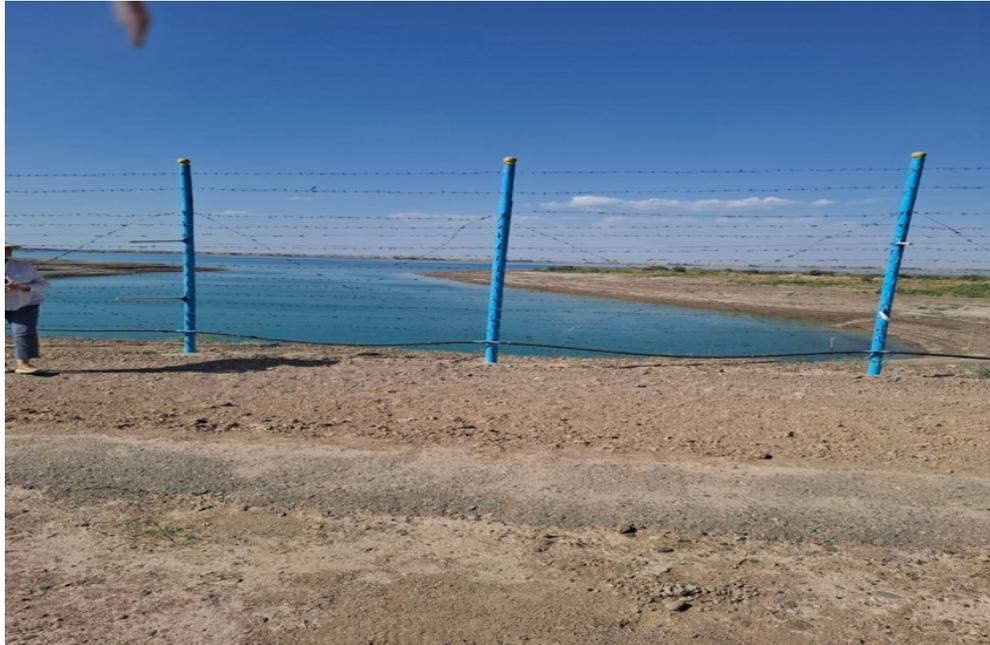
Access to Kuyimozor reservoirs – drinking water source – is guarded

The expedition confirmed the ecological and strategic importance of the Tudakul and Kuyimozor reservoirs. Under conditions of climate change and water scarcity, sustainable management of the reservoirs requires enhanced intersectoral cooperation — between water, environmental, and tourism agencies — as well as continuous monitoring of ecosystem conditions.

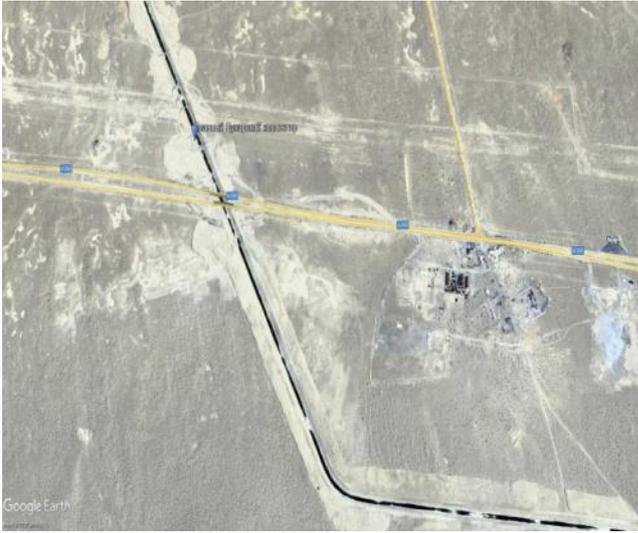
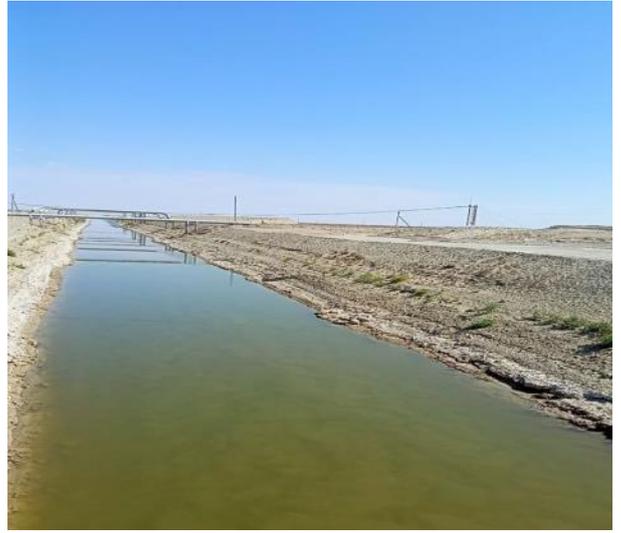
Watercourse indicated as “Bukhara Main Canal” on A-380 road

A visual inspection showed that the color, turbidity, and flow characteristics in the canal do not correspond to a natural source: water more closely resembles drainage flow. A detailed study of satellite images (Google Earth) of May 24, 2024 revealed that this watercourse is one of the branches of the Main Bukhara Collector. It originates in the area of Lake Shorkul and further branches out: the larger part of the flow crosses the state border with Turkmenistan and is discharged into the Amu Darya River in the territory of Turkmenistan.

In this context, it appears advisable to conduct additional survey of the watercourse to:

- find out its current purpose;
- determine the potentially irrigated (water-supplied) area;
- analyze technical characteristics of the canal;
- study existing operation scheme and water outflow regime.

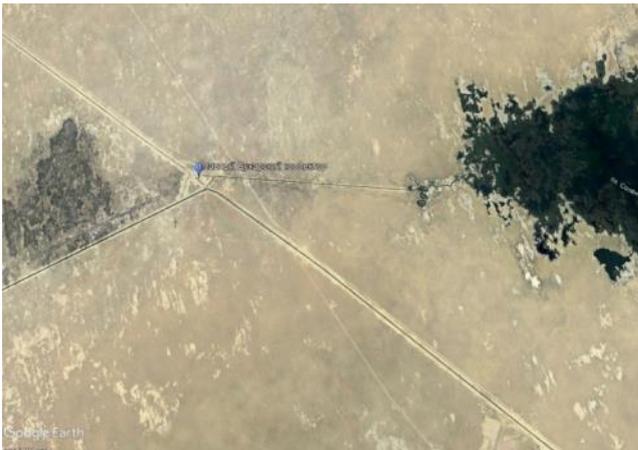
Head of Main Bukhara Collector near Lake Shorkul

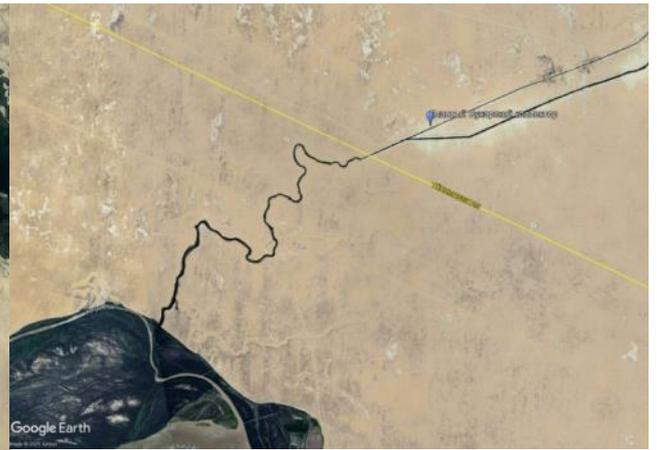
Discharge of collector water into the Amu Darya River in Turkmenistan

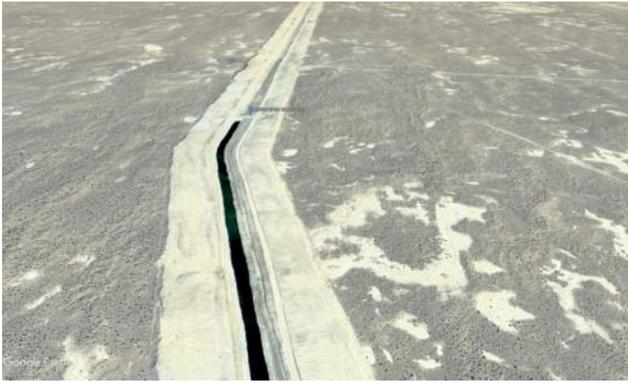
The watercourse marked as “Bukhara Main Canal” is directed toward a natural terrain depression located near Kala-Ata settlement. However, it has no outflow to active water receivers and terminates in a desert area, where water is presumably lost in a natural depression. At the time of analysis, this depression was dry. Moreover, in the section downstream of a bridge, approximately 2.2 km away, there is a dam, and no water was observed further downstream — the bed was dry. This probably indicates that the watercourse has no any economic or ecological function.

Damming of the collector

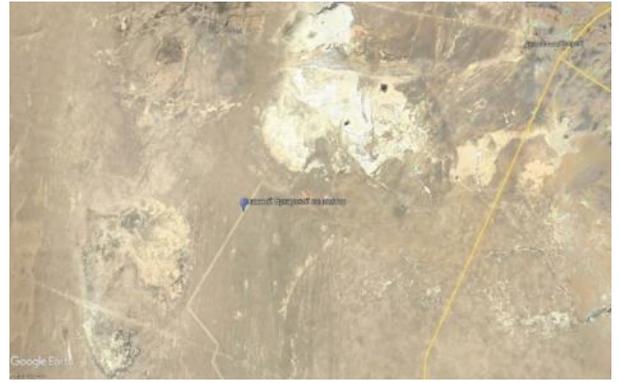
Collector's outlet

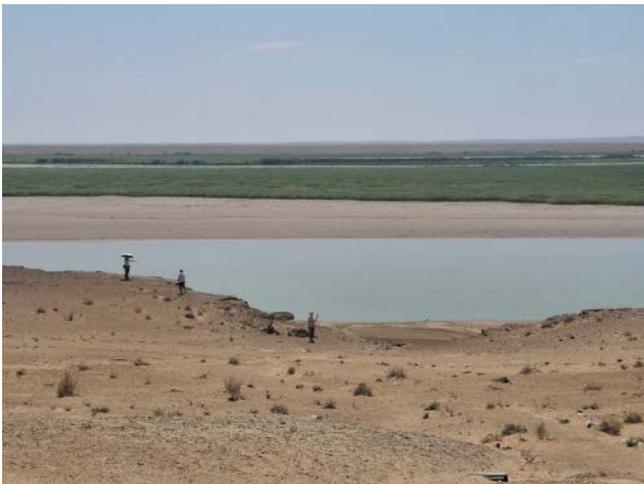
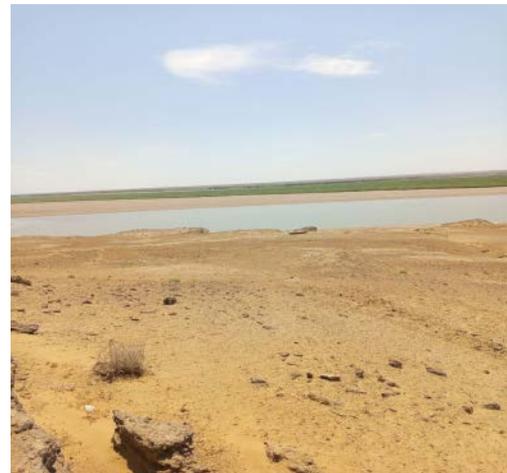
Further along A-380 road (approximately at 538 km), a visual inspection of the Amu Darya River was made. In this area, the river divides into numerous branches and arms, forming sandy islands. Such a morphological structure indicates to high dynamics of the river system in the delta and calls for its regular monitoring.

An arm of the Amu Darya River (A-380, 538 km)

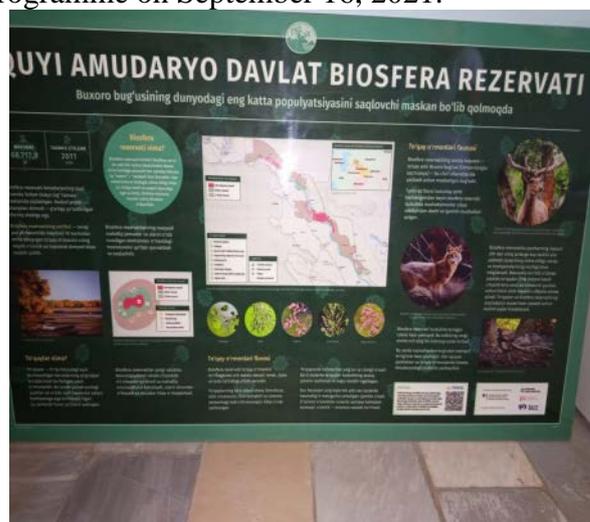
General layout of the territory

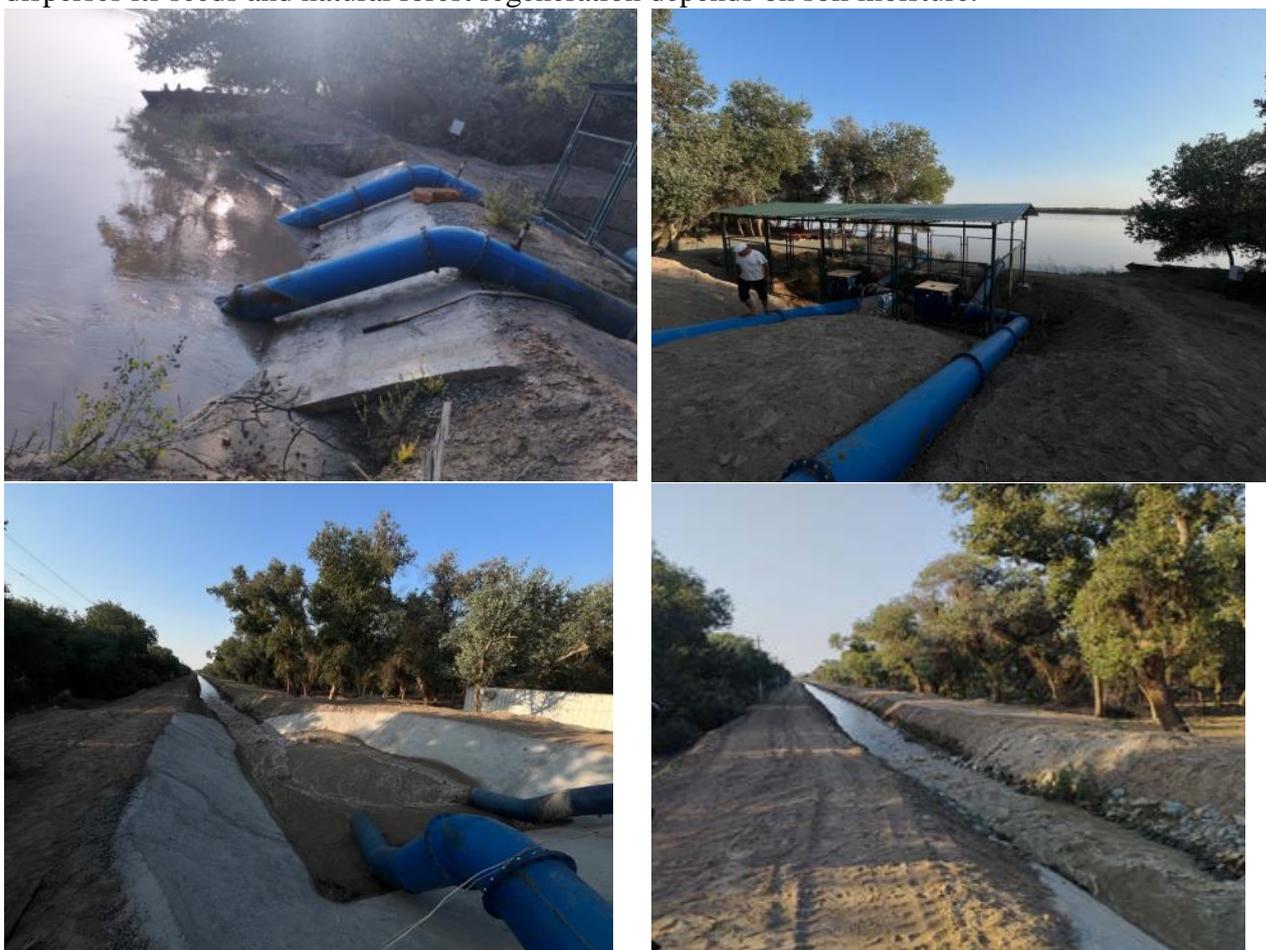
Unresolved issues of water supply. In the 1990s, as part of a World Bank's drainage project, a 40-km canal was constructed to deliver water to the reserve. However, water never reached the protected zone as it was diverted for irrigation of agricultural fields along the canal's. In 2023–2024, the Ministry of Ecology implemented a project to improve the habitat of the Bukhara deer and preserve riparian vegetation: a new 3-km canal was built, and two electric pumps were installed. Nevertheless, the canal has not yet been officially transferred to ownership of reserve's administration, which apparently prevents the allocation of funds for power supply. According to staff, at the time of the visit, water was supplied by only one pump (about 500 liters per second). Water is especially critical for the reserve in July–August, when Asiatic poplar disperses its seeds and natural forest regeneration depends on soil moisture.

A new canal and pumps to recharge reserve's ecosystems

It is necessary to ensure regular water supply to the nature reserve to prevent ecosystems from further degradation. Reasonable measures include:

- assess the reserve's demand and formally include in the water quotas;

- consider the possibility of additional use of groundwater, including arrangement of local dams on the edges of the territory since the current 3-km canal cannot meet the needs of the vast reserve;
- speed up the transfer of the newly constructed canal to ownership of reserve’s administration, which would allow for budgetary funding of operational costs.

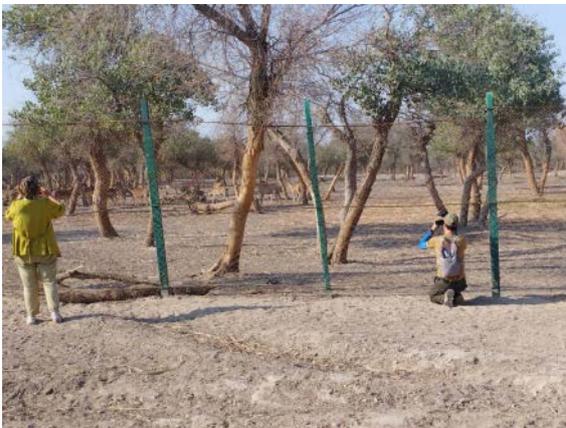
Overpopulation of Bukhara deer and deterioration of food supply. Since 1976, when the first three deer were introduced into the reserve from Tajikistan, the population has grown significantly. Today, LASBR itself is engaged in resettling animals, although no large-scale relocations take place. Approximately 1,600 Bukhara deer are currently present—three times the permissible capacity - in the Baday-Tugai section. This has led to pasture degradation, especially under conditions of water scarcity. Vegetation recovery in such circumstances is extremely difficult. Reserve’s staff has proposed to partially relocate deer to the left bank of the Amu Darya, where the forage base is more reliable. However, this measure would require the construction of a 30-kilometer fence, which in turn demands substantial investments.

Bukhara deer enclosures

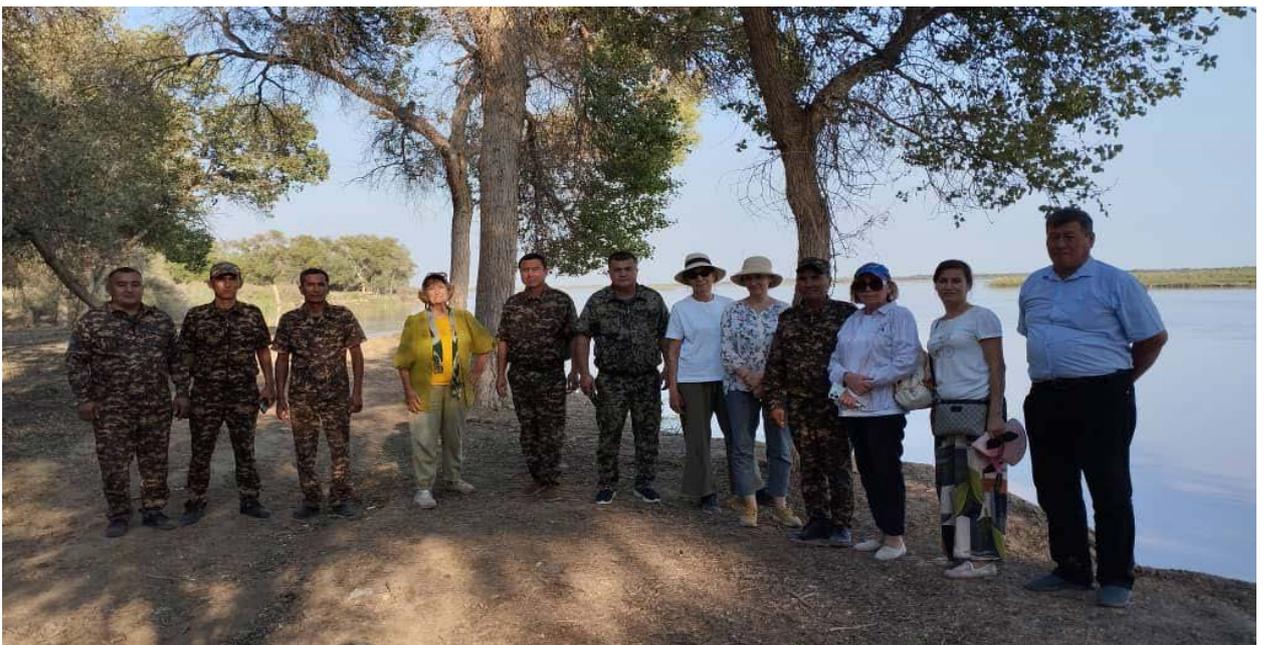
Amu Darya’s bank, LASBR area near the pumping station

Lower Amu Darya Biosphere Reserve (Baday-Tugai). An assessment of functioning of the artificial watering system for floodplain forests was made. It was found that the existing canal and pumping equipment require stable and guaranteed funding for proper operation. Additional problems identified include: (1) overpopulation of Bukhara deer, with numbers exceeding the permissible capacity threefold, and (2) degradation of the forage base, particularly under water scarcity. It is recommended to: include power supply for pump operation in the reserve's administration budget; consider solutions such as drilling wells and creating dams on the edges of the reserve; and, partially relocate the deer population to alternative sites, where the forage base is more reliable.

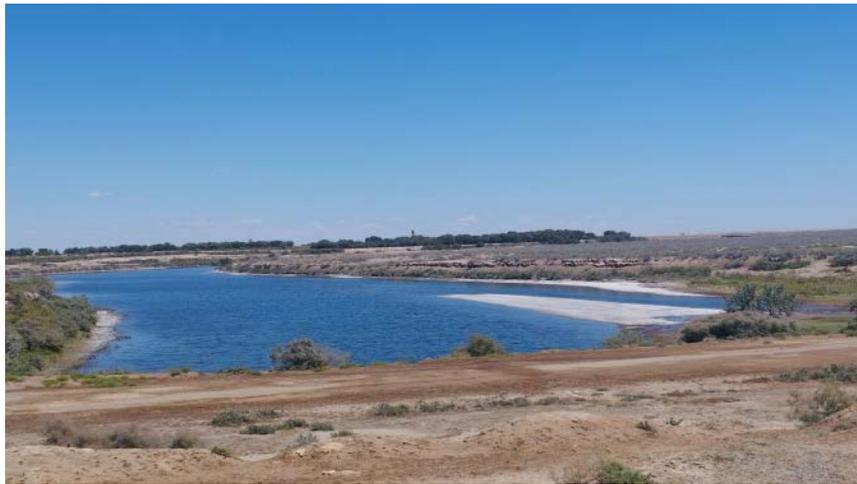
The old channel of the Kipchakdarya - one of the five arms that formerly flowed into the Aral Sea. Water in the channel is sustained by seepage from the Mezhdurechye Reservoir and inflow from groundwater. This arm joins the former main channel of the Amu Darya (Akdarya) near Porlytau village. According to the satellite data for July 2025, water is available along a stretch of approximately 2.4 km at the confluence of the Kipchakdarya and Akdarya.

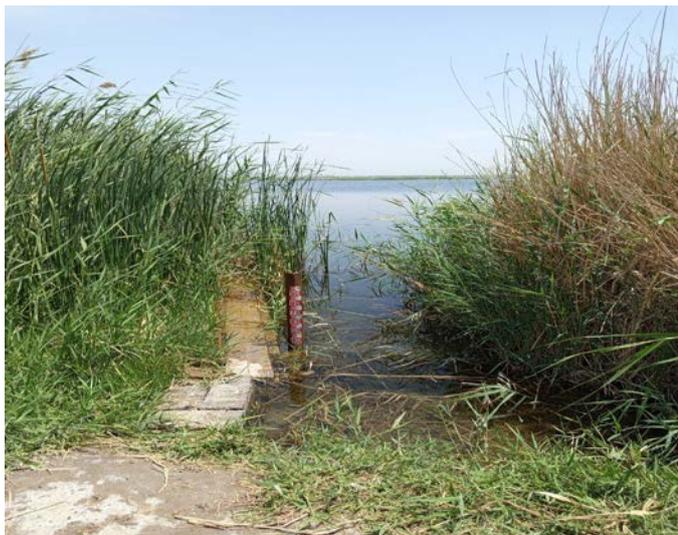
The team visited Lake Gulik, where one of Hydromet's monitoring stations is located. The station measures water level and salinity, and representatives noted that lake's salinity is increasing.

1. The museum needs cosmetic repairs.
2. The staff (keepers) is insufficiently equipped with essential tools for their work, such as firearms, vehicles, uniforms, and communication.
3. The causes of increasing lake salinity or measures to prevent it are not studied.
4. The reserve's territory is affected by salinization, which is reducing the area of *Elaeagnus* vegetation.
